**Flood Control Project Maintenance
Levee Inspections**
LMA District Cover Sheet
Spring 2019 Levee Inspection Results

Reclamation District No. 0349 Sutter Island

Spring 2019 Levee Inspection Results

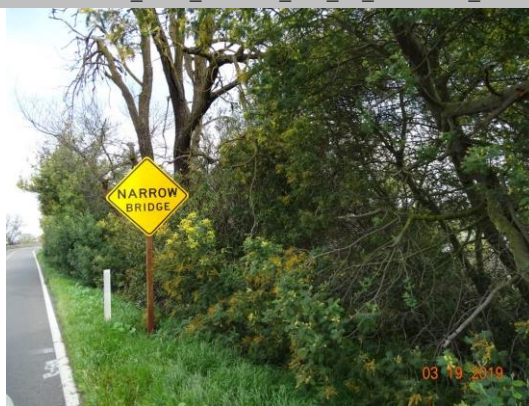
Photo 1 of 1 : SP_2019_RD0349_204_20_20190320_00033.jpg

View looking upstream at landscape vegetation on the waterside slope (Spring 2019).

LM Start	0.01	Rating **	A/W	Issue No.	9
LM End	0.10	Issue Type +	Ma	Location *	WS
Category	Supplemental			GPS Latitude/Longitude	
				Start	End
Item	2017 USACE Erosion Survey, DRAFT			38.326996 °	38.325798 °
				-121.576557 °	-121.577027 °
DWR ID	DWR_RD0349_01_f_2018_9				
Comment Code					
Inspector Comment					
2017 Site ID: SAC 33.9 R					
Status: Critical					
2017 Field Notes: New erosion pocket. Tree roots propped up with junk. Tree likely to fall and house to come tumbling after. Upgraded to critical.					
Site History: 2015 - Erosion observed at the toe.					
2018: Vegetation was too thick to observe completely but did look like tree was likely to fall soon.

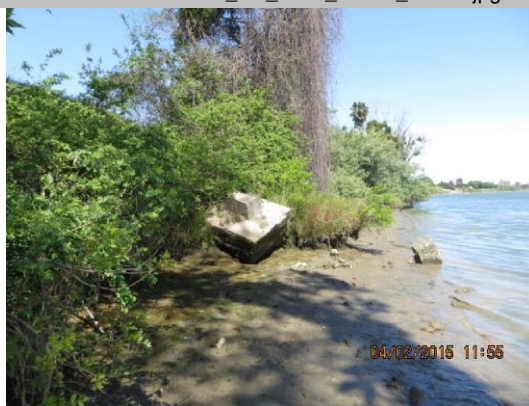
Photo 2 of 3 : UCIP_SP_2019_44303_73621.jpg

Comment Code						
Inspector Comment						
FS_ID:44303						
DS_ID:24137						
EP_NO: N/A						
Repair Type: Non-Urgent						
Crossing Status: Indicator Found						
UCIP Comments: Pipe appears to be abandoned and if so should be done so properly. Electromagnetic survey indicated a crossing at this location.						
FIELD_STRUCT_DESC: *ABANDONED* 10-inch irrigation pipe of unknown material through the levee, 3.8 feet below the levee crown. Power pole and anchor on the landside (LS). Deteriorated concrete box at the LS toe. Concrete debris on the waterside (WS) toe good indicator of pump location. [Additional Reference(s): DWR Levee Log, 2005. USACE Sacramento O&M Manual Unit No. 110, May 1959, revised 29 Dec 2016, (HLM 0.1)]						
FS Date: 4/2/2015

Concrete debris on WS toe is a good indicator of pump location.

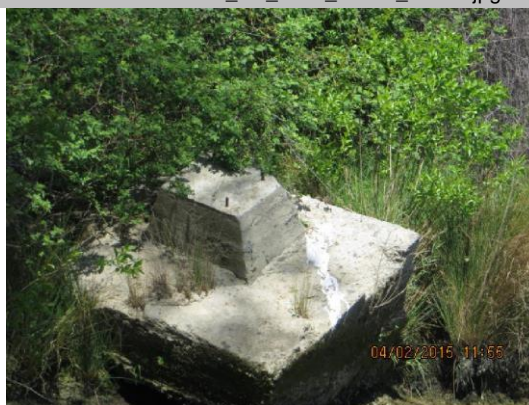
Photo 3 of 3 : UCIP_SP_2019_44303_73620.jpg

Concrete debris on WS toe is a good indicator of pump location.

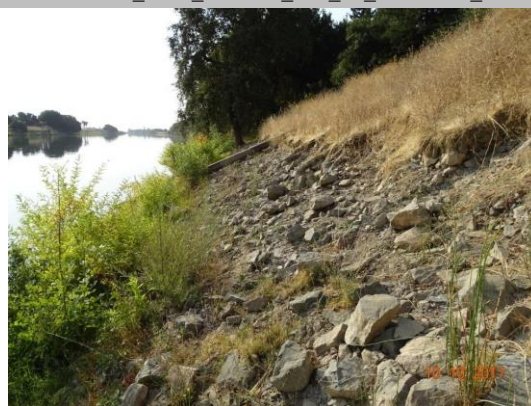
Photo 1 of 1 : SP_2019_RD0349_204_15_20190311_00002.jpg

LM Start	1.00	Rating **	M	Issue No.	15
LM End	1.06	Issue Type +	Ma	Location *	
Category	Supplemental			GPS Latitude/Longitude	
				Start	End
Item	2017 Storm Damage		38.312911 °	38.312131 °	
			-121.578528 °	-121.578292 °	
DWR ID	DWR_RD0349_01_f_2017_15

Comment Code					
Inspector Comment					
Levee Evaluation Comments					
Description:District Station 52+92 to 55+88, Sec. 06, T. 5 N. R. 4 E., M.D.M. Approximately 296 linear-feet of eroded area exists along the waterside levee slope of the Sacramento River (Unit 1). Erosion commences at approximately 3/4 of the way down the slope from the crown and extends into the rip rap. Some rip rap has been pulled off in this section.					
Site ID No:318					
Site Designation:LMA-145					
Repair Type: Erosion					
Rating:Area of Concern					
Field Date:7/28/2017					
Notes: slope too steep, vegetation too thick for clear inspection, no direct visual of damage

Waterside erosion at LM 1.02.

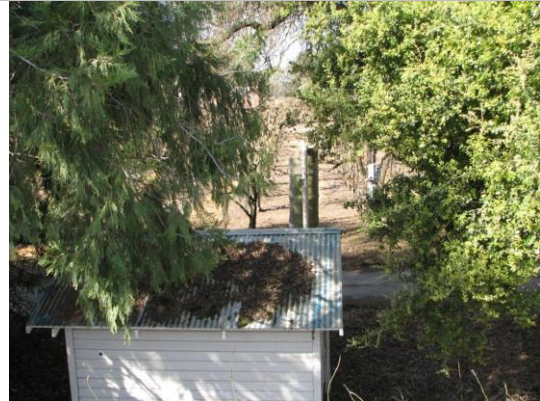
Photo 3 of 3 : UCIP_SP_2019_50013_36556.jpg

Comment Code						
Inspector Comment						
FS_ID:50013 DS_ID:24140 EP_NO: N/A Repair Type: Non-Urgent Crossing Status: Found UCIP Comments: 8/22/2016 Crossing has been downgraded from Urgent to Non-Urgent no signs of pipe failure were visible during site inspection. Minor erosion visible on LS shoulder covered by dry leaves. No permit was found--need to contact owner to determine age of crossing and determine when the last internal inspection was completed. (DWR UCIP - omagana)8/13/2009 Exposed section of levee slope on LS--need to contact owner and DWR inspector. Dense vegetation limits the inspector's visibility to identify signs of pipe failure (leaks) along the slope. Recommend removing vegetation along pipe alignment to conduct proper inspection of structure and appurtenances. Note date on photos should be 3/18/09 not 7/26/08 camera metadata is incorrect. (DWR UCIP - omagana) FIELD_STRUCT_DESC: 14-inch steel irrigation pipe (waterside (WS) shoulder) and 12-inch pipe (landside (LS) shoulder) through the levee, 4.7 feet below the levee crown. Gate valve on the WS slope. Pump in pump house on LS slope. Pressure breaker behind pump house. Pipe exposed on WS slope. [Additional Reference(s): DWR Levee Log, 2005. USACE San Joaquin O&M Manual Unit No. 110, May 1959, HLM 1.1, 14-inch pipe with pump on WS] FS Date: 8/17/2016

View of LS: pump house, concrete stand pipe, and electric pole.

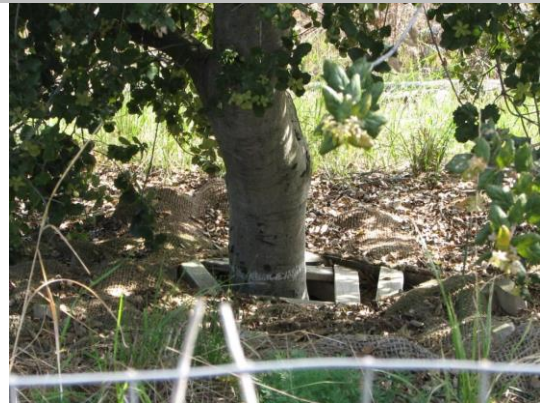
Photo 1 of 3 : UCIP_SP_2019_44304_36580.jpg

Comment Code						
Inspector Comment						
FS_ID:44304 DS_ID:24141 EP_NO: N/A Repair Type: Non-Urgent Crossing Status: Found UCIP Comments: 2007 DWR erosion repair site location?--need to find out fate of crossing. Dense vegetation limits the inspector's visibility to identify signs of pipe failure (leaks) along the slope. Recommend removing vegetation along pipe alignment to conduct proper inspection of structure and appurtenances. Note date on photos should be 3/18/09 not 7/26/08 camera metadata is incorrect. FIELD_STRUCT_DESC: *ABANDONED* Pump house located on landside (LS) toe. Pressure breaker on LS. Electromagnetic Survey indicates a crossing at this location. [Additional Reference(s): DWR Levee Log, 2005] FS Date: 4/2/2015

Geotech fabric and protective frame at tree--design features of erosion repair site 2007-2009.

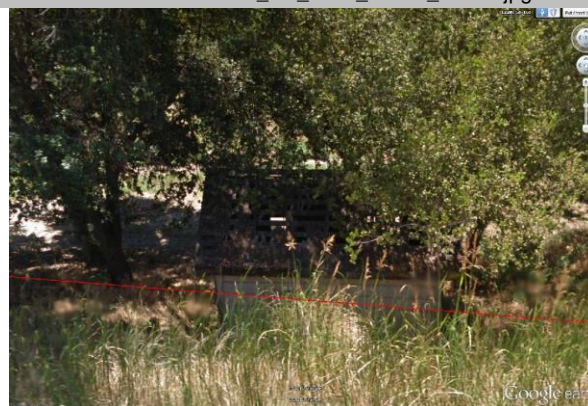
Photo 2 of 3 : UCIP_SP_2019_44304_73625.jpg

Pumphouse on LS toe (From google view)

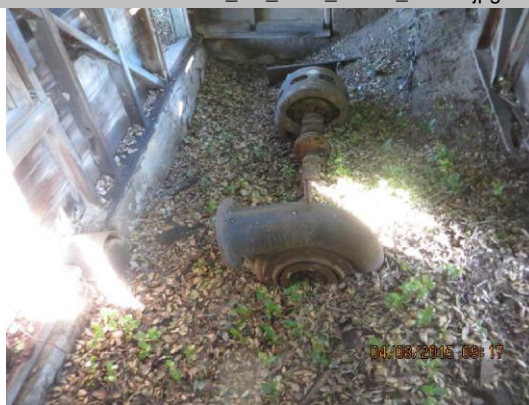
Photo 3 of 3 : UCIP_SP_2019_44304_73680.jpg

Pump and motor inside pumphouse at LS toe. No pipe visible.

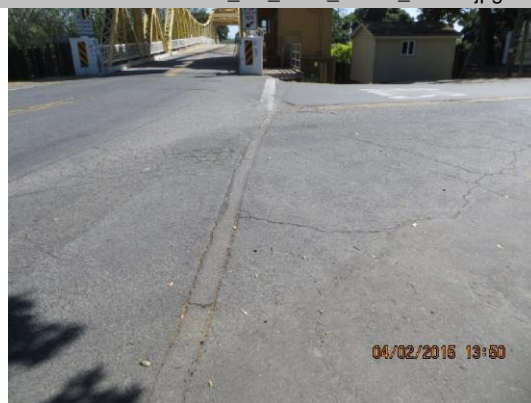
Photo 1 of 3 : UCIP_SP_2019_46168_74542.jpg

Cut in pavement good indicator of pipe location.

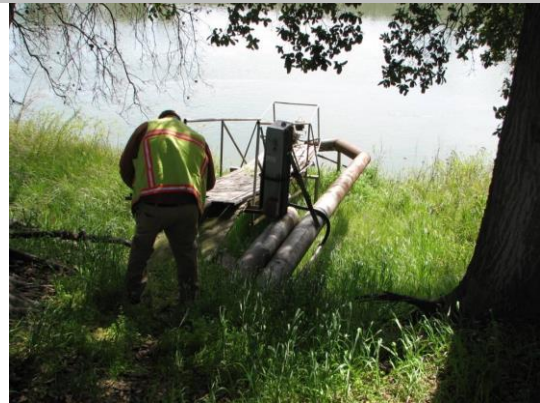
Photo 1 of 3 : UCIP_SP_2019_21576_36593.jpg

Dense vegetation on waterward slope--2 pipes and 1 conduit.

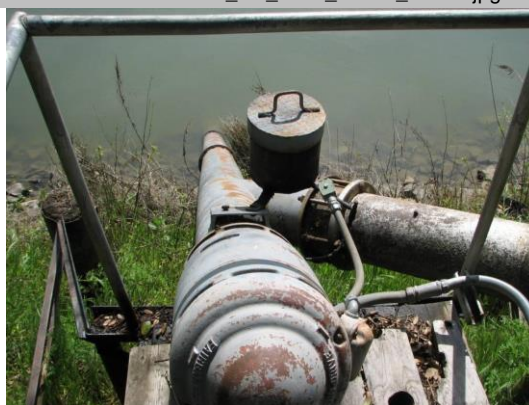
Photo 2 of 3 : UCIP_SP_2019_21577_36596.jpg

View of waterward side--pump and raised platform.

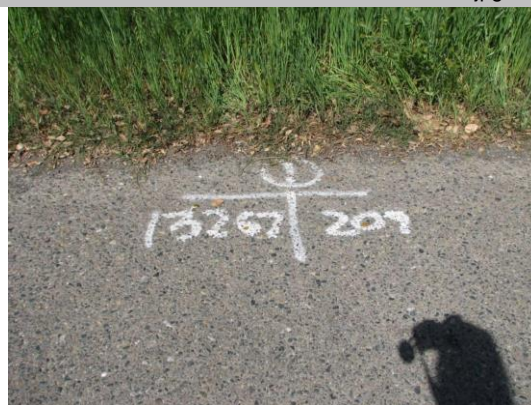
Photo 1 of 3 : UCIP_SP_2019_21613_36685.jpg

Underground service alert (USA) marking on levee crown.

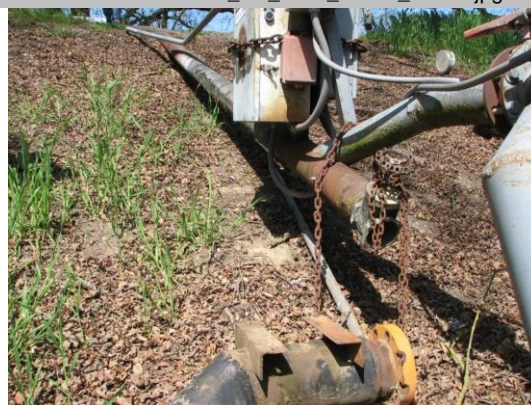
Photo 2 of 3 : UCIP_SP_2019_21614_36690.jpg

Crossing has been altered--abandoned pipe through levee slope remains.

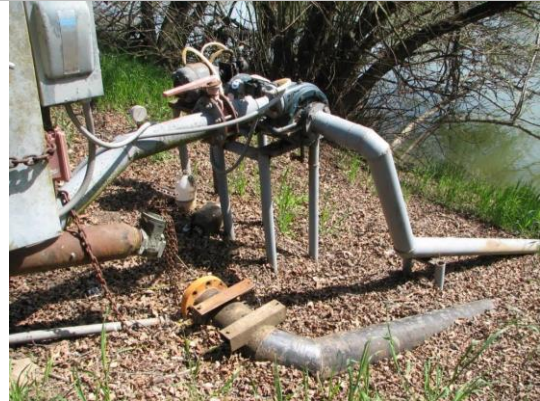
Photo 3 of 3 : UCIP_SP_2019_21614_36689.jpg

New configuration--sections of pipe have been abandoned.

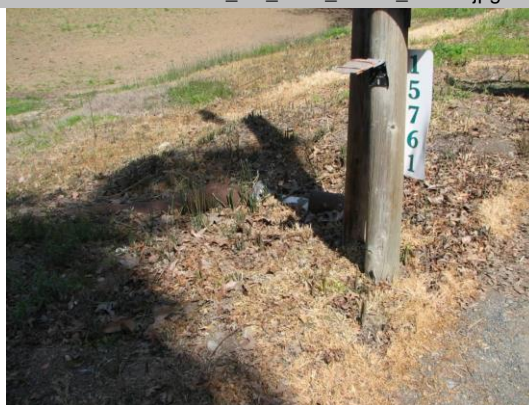
Photo 2 of 3 : UCIP_SP_2019_21615_36695.jpg

View of landard shoulder--service pole and pipe section through slope.

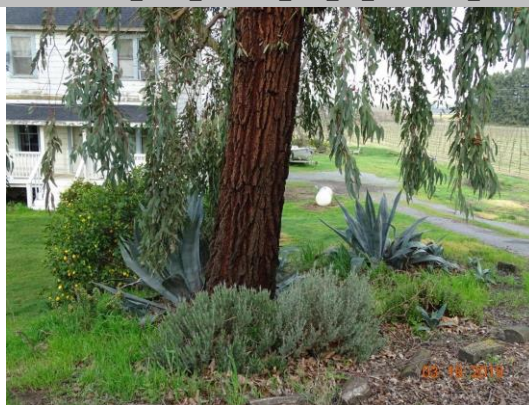
Photo 1 of 1 : SP_2019_RD0349_205_52_20190320_00106.jpg

View of cactus on the landside slope (Spring 2019).

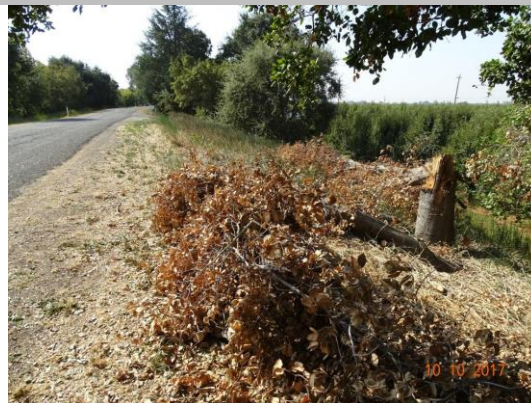
Photo 1 of 1 : SP_2019_RD0349_205_7_20190311_00006.jpg

Fallen tree on landside slope.

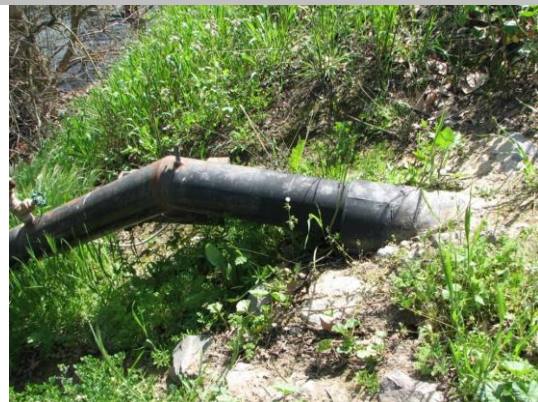
Photo 2 of 3 : UCIP_SP_2019_21606_36654.jpg

Smaller pipe sleeved through larger pipe that goes through levee.

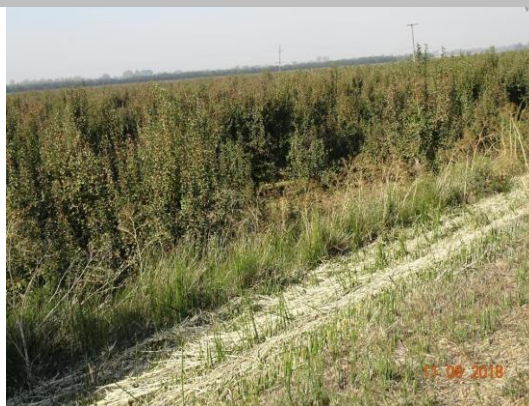
Photo 1 of 1 : SP_2019_RD0349_205_61_20190311_00041.jpg

View of orchard trees on the landside toe (November 2018).

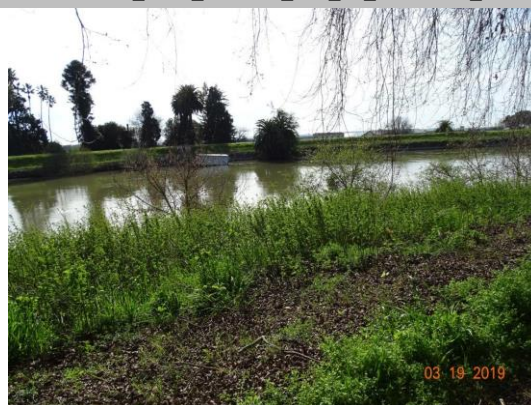
Photo 1 of 1 : SP_2019_RD0349_205_91_20190320_00110.jpg

View of wild growth on the waterside slope (Spring 2019).

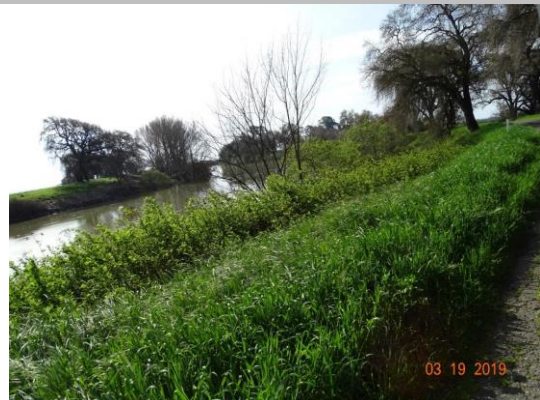
Photo 1 of 1 : SP_2019_RD0349_205_92_20190320_00111.jpg

View looking downstream of thick wild growth on the waterside slope (Spring 2019).

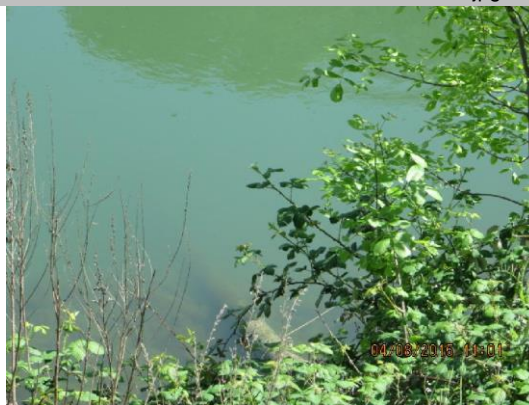
Photo 2 of 3 : UCIP_SP_2019_44328_73706.jpg

Pipe visible in water at WS toe.

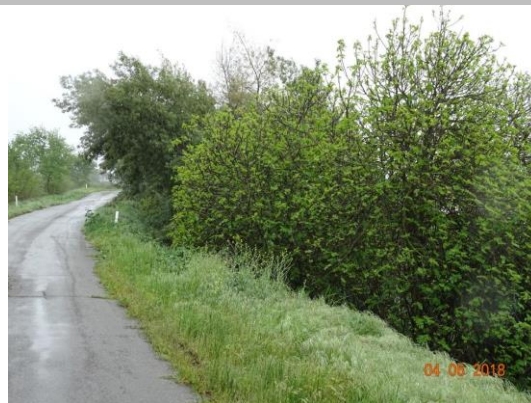
Photo 1 of 1 : SP_2019_RD0349_205_80_20190311_00048.jpg

View of dense landside landscaping

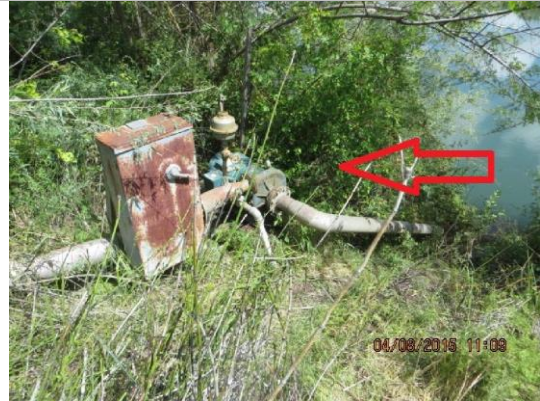
Photo 1 of 3 : UCIP_SP_2019_53344_73709.jpg

Abandoned pipe visible on slope in vegetation behind new pipe on WS slope.

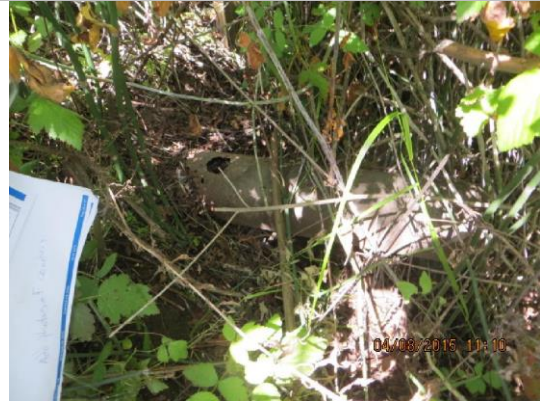
Photo 2 of 3 : UCIP_SP_2019_53344_73708.jpg

Abandoned pipe visible on slope in vegetation behind new pipe on WS slope.

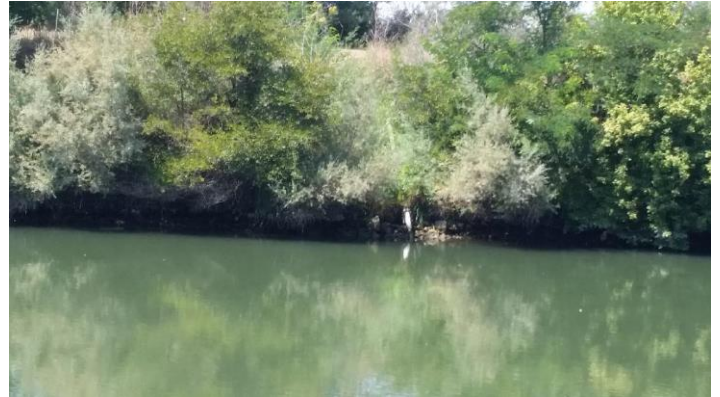
Photo 3 of 3 : UCIP_SP_2019_53344_75632.jpg

Pipe visible from opposite bank.

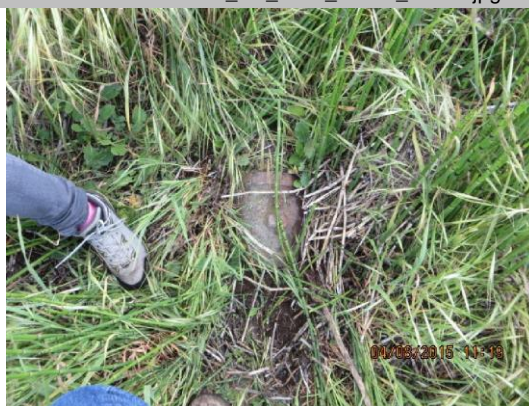
Photo 1 of 3 : UCIP_SP_2019_46172_74553.jpg

Pipe just visible on LS slope.

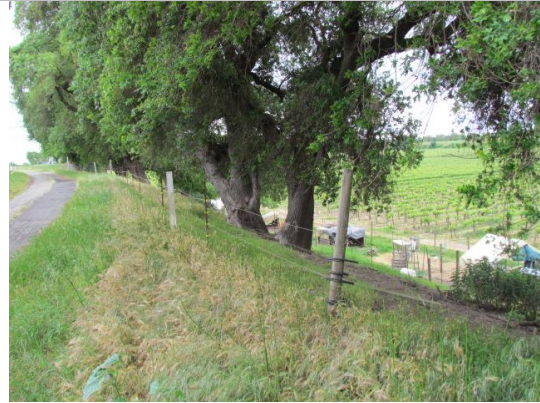
Photo 1 of 1 : SP_2019_RD0349_205_59_20190311_00039.jpg

Unauthorized electric fence along the landside shoulder and levee slope

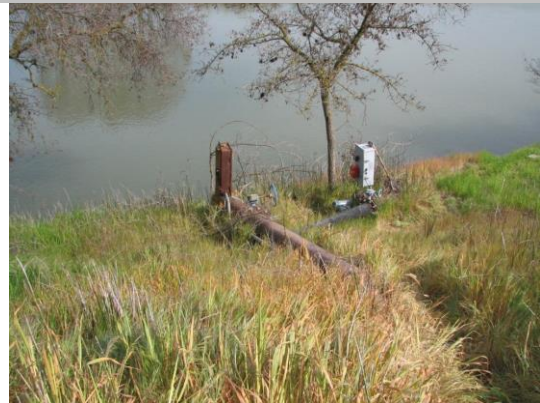
Photo 1 of 3 : UCIP_SP_2019_21612_36684.jpg

Overview of waterward side--2 crossings.

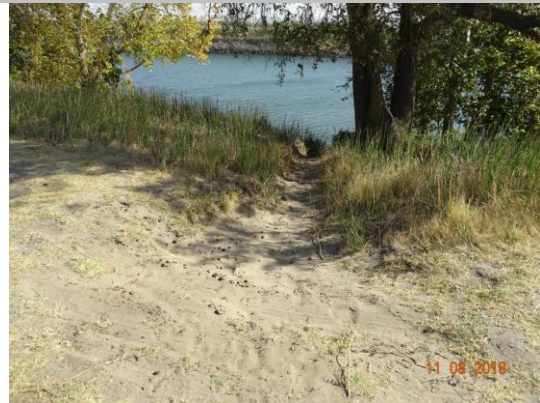
Photo 1 of 1 : SP_2019_RD0349_205_35_20190311_00019.jpg

View of footpath going down the waterside slope (November 2018).

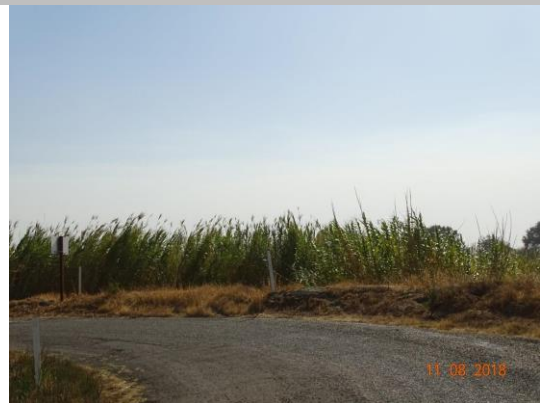
Photo 1 of 1 : SP_2019_RD0349_205_30_20190311_00014.jpg

View of arundo on the waterside slope (November 2018).

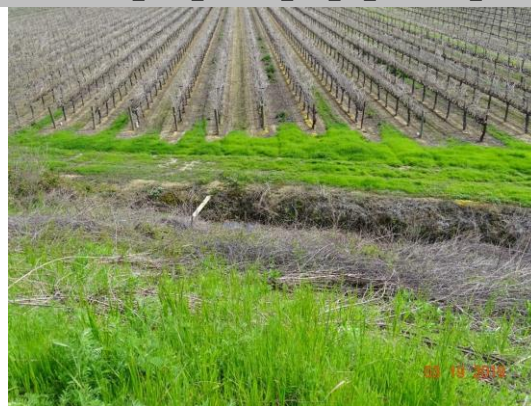
Photo 1 of 1 : SP_2019_RD0349_206_41_20190320_00085.jpg

View of ditch at the landside toe (Spring 2019).

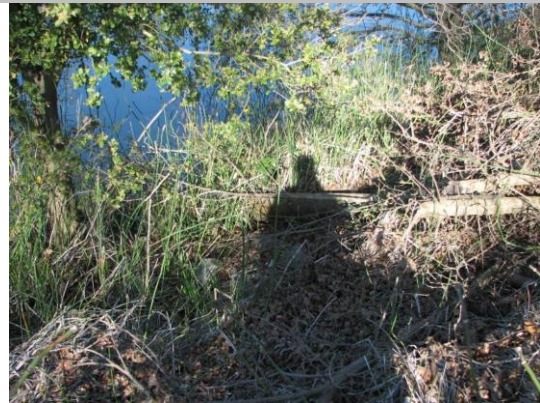
Photo 1 of 3 : UCIP_SP_2019_43442_36707.jpg

View of waterward side--portion of pipe exposed on slope.

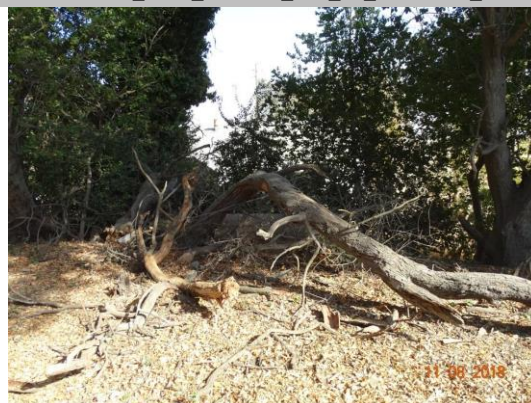
Photo 1 of 1 : SP_2019_RD0349_206_67_20190311_00009.jpg

View of down tree on the land side shoulder (November 2018).

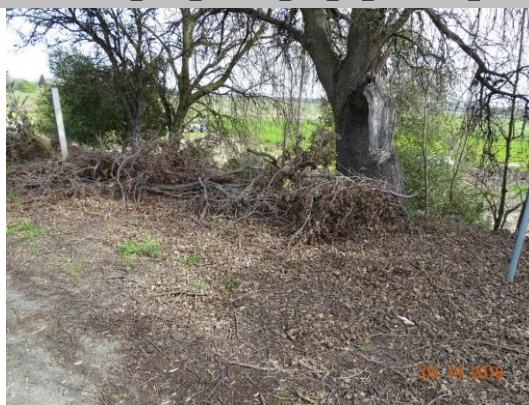
Photo 1 of 1 : SP_2019_RD0349_206_47_20190320_00088.jpg

View of tree trimmings on the landside shoulder (Spring 2019).

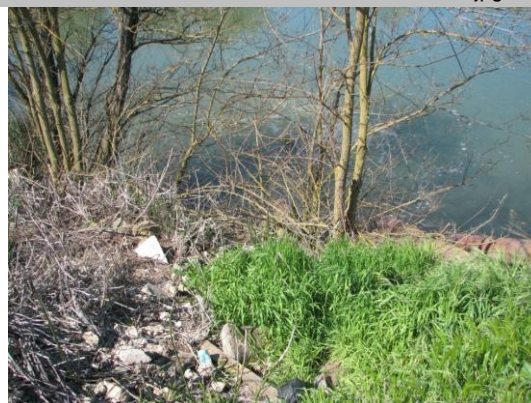
Photo 2 of 2 : UCIP_SP_2019_43446_36726.jpg

View of all 3 pipes through levee and visible on waterward toe.

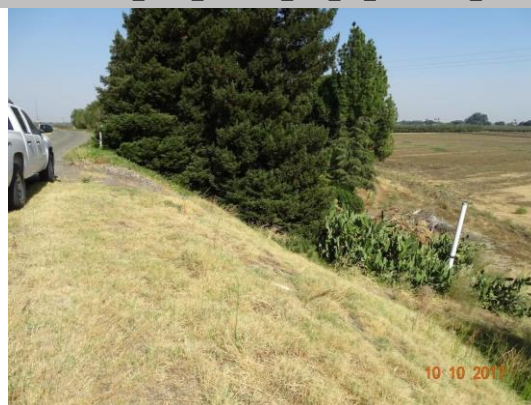
Photo 1 of 1 : SP_2019_RD0349_206_39_20190311_00006.jpg

Landscaping on landside at LM 1.67.

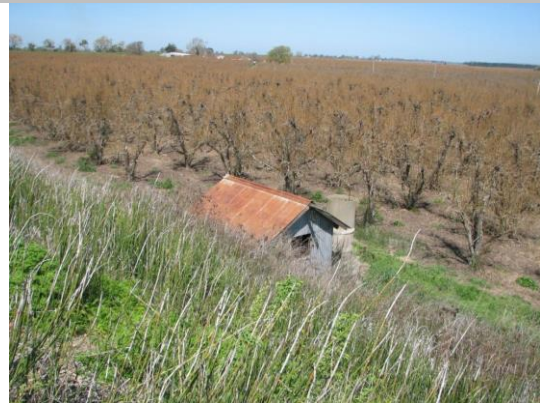
Photo 1 of 2 : UCIP_SP_2019_21634_36739.jpg

View of landward side--pump house and stand pipe.

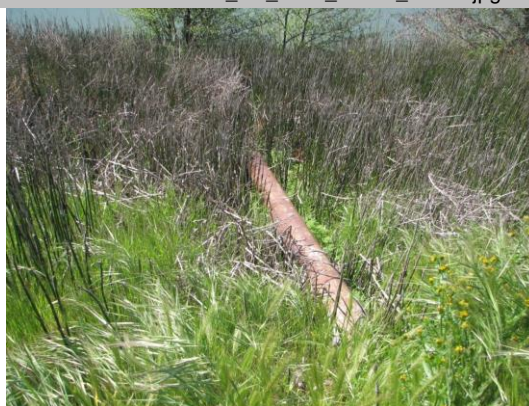
Photo 2 of 2 : UCIP_SP_2019_21634_36738.jpg

View of waterward side--dense vegetation limits inspection.

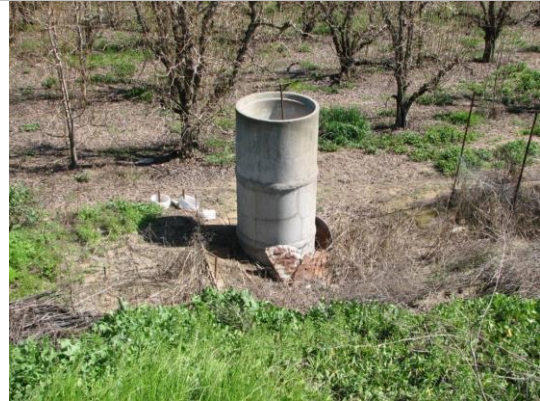
Photo 3 of 3 : UCIP_SP_2019_43423_36867.jpg

Stand pipe located on landward toe.

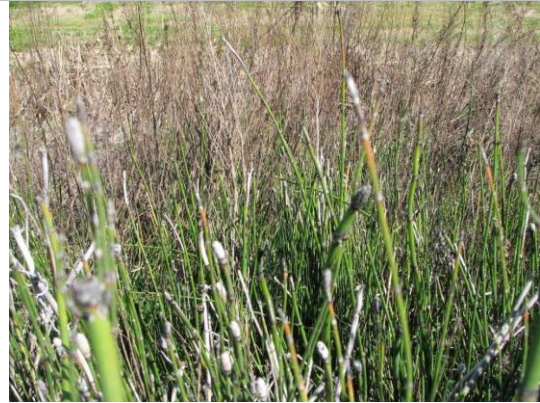
Photo 3 of 3 : UCIP_SP_2019_43424_36868.jpg

View of landward side--dense vegetation on slope limits inspection.

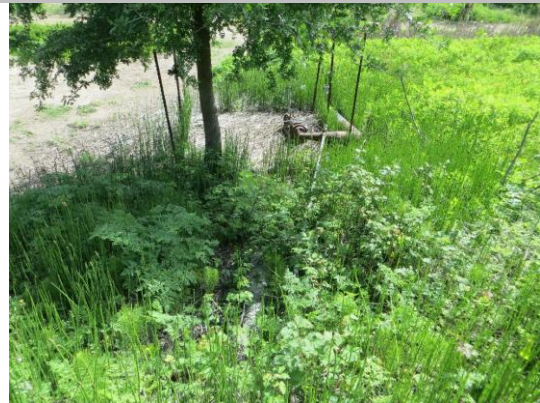
Photo 1 of 3 : UCIP_SP_2019_53345_73743.jpg

Pipe and pump platform on LS toe.

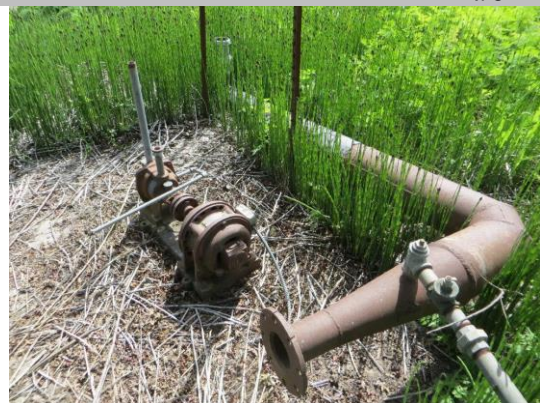
Photo 3 of 3 : UCIP_SP_2019_53345_73741.jpg

Abandoned pump at LS toe.

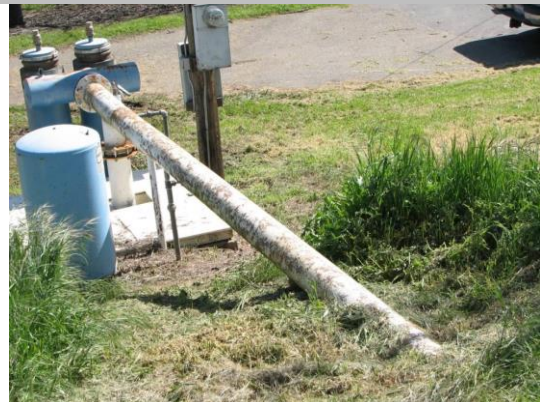
Photo 1 of 2 : UCIP_SP_2019_44390_73745.jpg

Pipe, filter system, powerpole, and distribution box at LS toe.

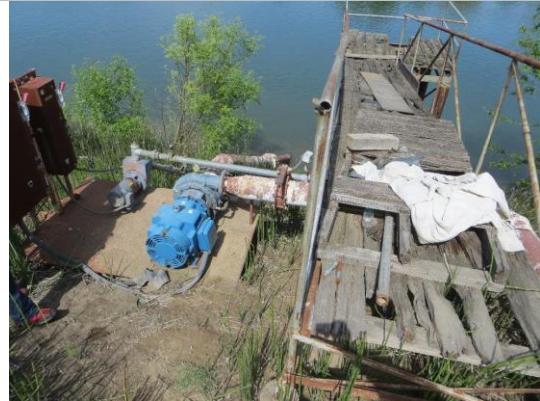
Photo 2 of 2 : UCIP_SP_2019_44390_73746.jpg

Pump, electrical panel, butterfly valve, and walkway on WS slope.

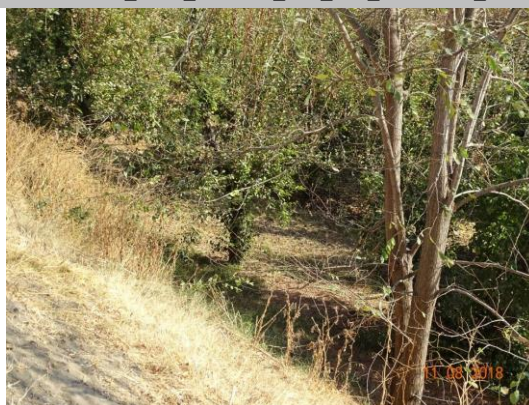
Photo 1 of 1 : SP_2019_RD0349_206_103_20190311_00017.jpg

View looking slightly upstream at orchard trees on the landside toe (November 2018).

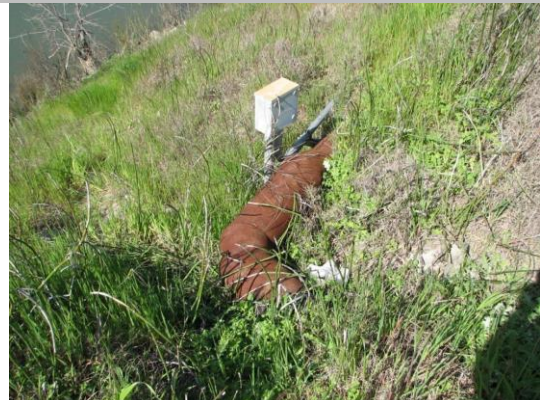
Photo 2 of 3 : UCIP_SP_2019_21644_36778.jpg

90 elbow at daylight and continues along slope and connects to pump.

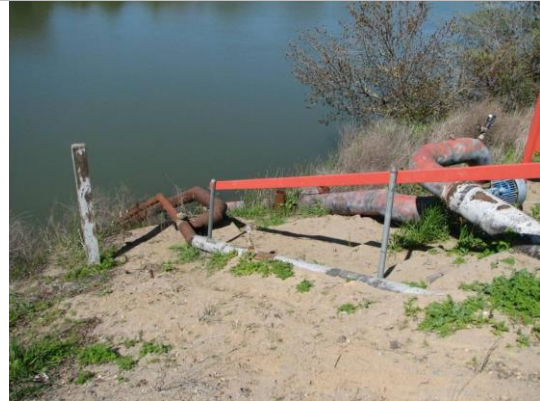
Photo 1 of 1 : UCIP_SP_2019_43458_36784.jpg

View of waterward side. 2 crossing visible 12-inch and 6-inch pipes.

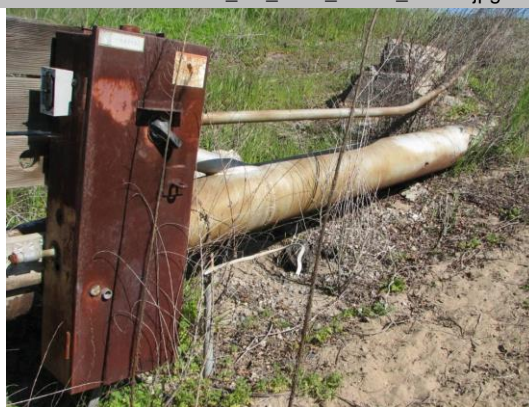
Photo 3 of 3 : UCIP_SP_2019_43459_36797.jpg

Pipe on waterward side.

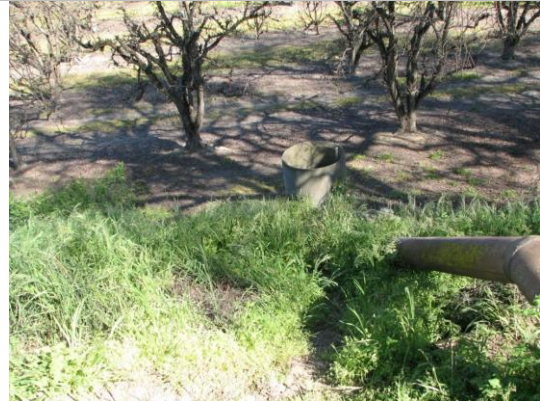
Photo 1 of 3 : UCIP_SP_2019_50016_36841.jpg

View of LS--pipe and stand pipe visible.
